Re: Task 3 Dam Assessment Report
Project #0-381
Clifty Creek Station
South Fly Ash Pond
Madison, Indiana

EXECUTIVE SUMMARY

This Phase I Inspection/Evaluation Report details the results of a visual dam inspection of the Clifty Creek South Fly Ash Pond Dam (SFAP), located in Madison, Jefferson County, Indiana. The entrance to the plant is at Clifty Hollow Road, Route 56. The inspection was performed on June 11, 2009 by GZA GeoEnvironmental, Inc (GZA).

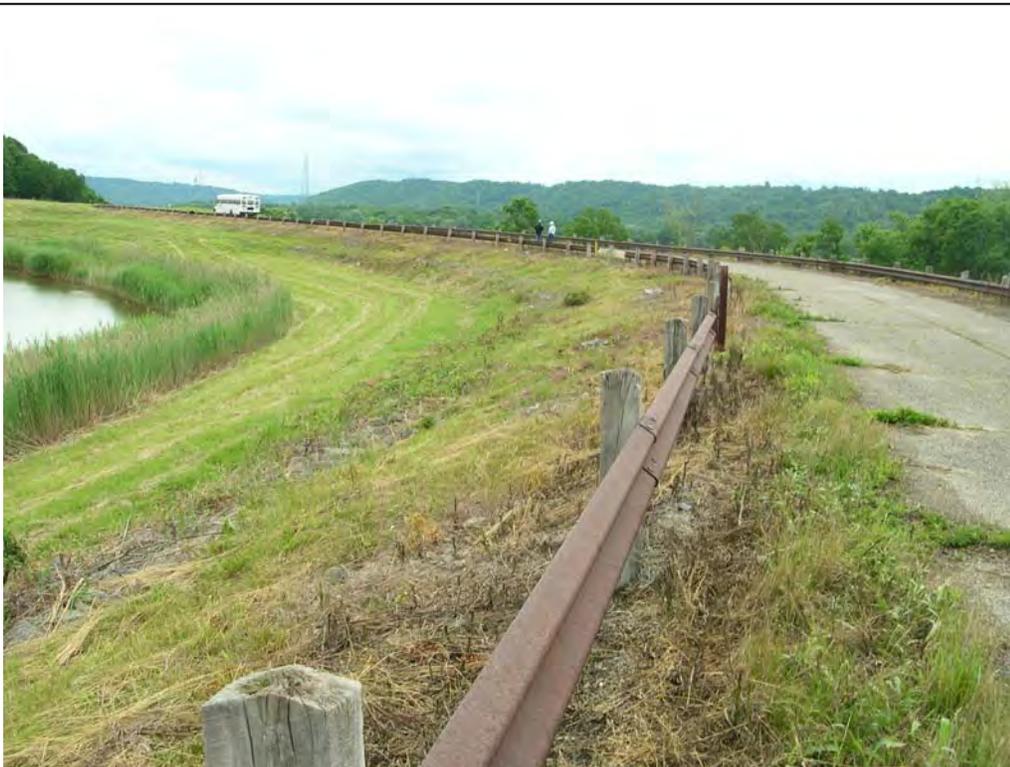
#2 – Upstream Face and Roadway at Crest with Wetland Growth at Pond Level

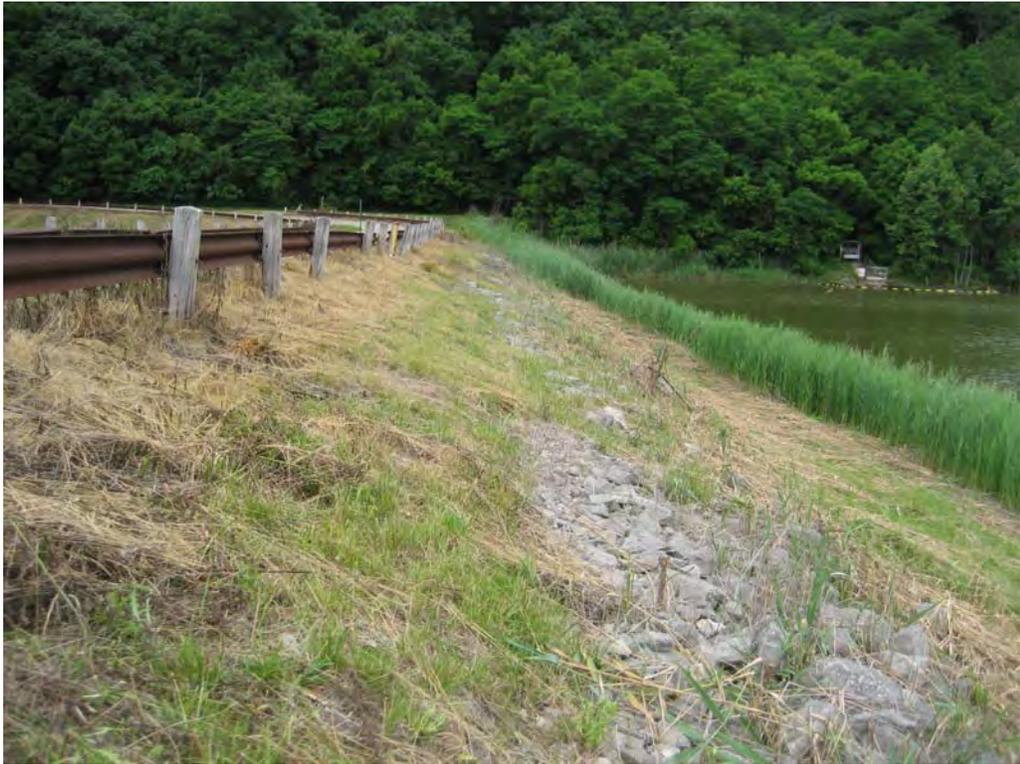
#5 – Upstream Slope; Note Riprap Protection

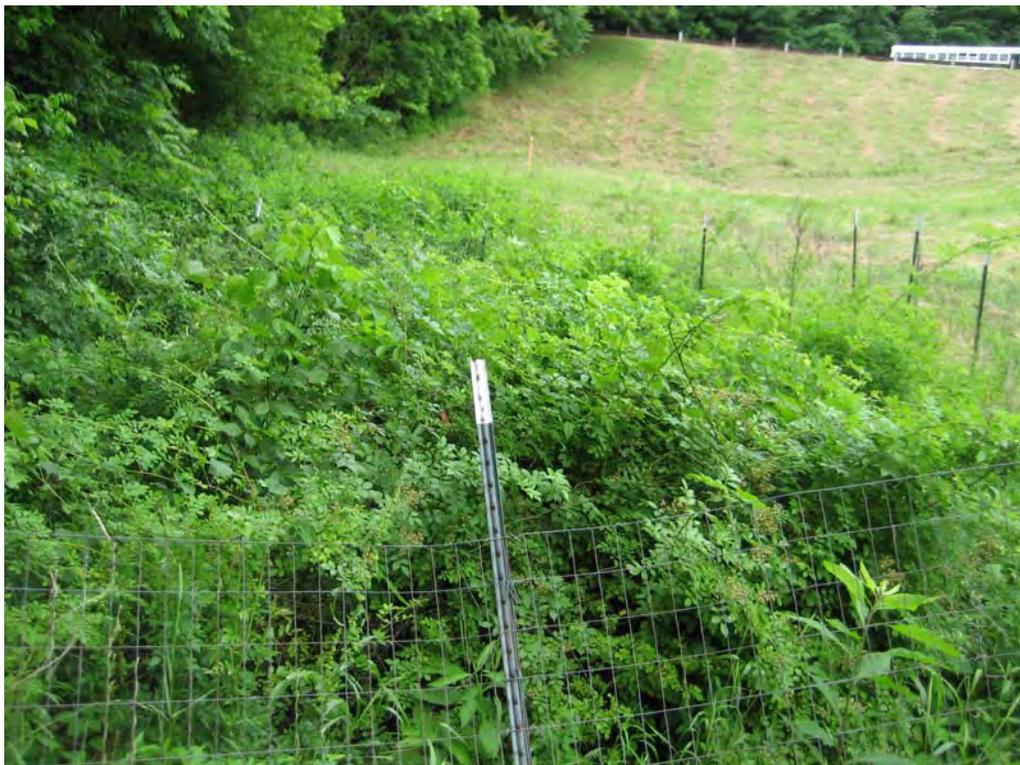
#10 – Downstream Slope Looking Up Toward Crest Near Right Groin. Overgrowth of Vegetation Near Outfall in Foreground of Picture.

1. Dense scrub vegetation covers the outfall to the 72-inch pipe at the toe of the dam. This vegetation should be removed and replaced with short grass cover to increase visual inspection in the future.
2. Numerous minor scarps existing on the downstream face of the saddle dike embankment. These should continue to be monitored for movement.
3. The floating debris boom at the spillway intake is in poor operating condition and should be repaired or replaced to better prevent debris from penetrating the intakes.

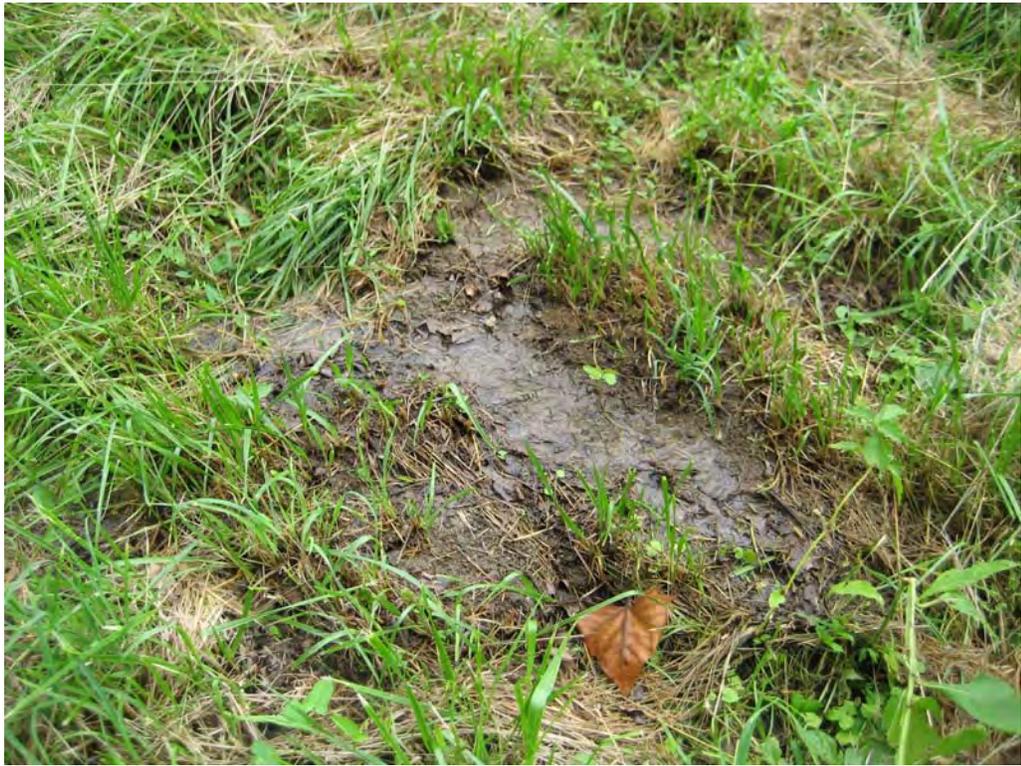
The downstream slope of the dam is generally in good condition. The face is consistently covered with grass, which was recently mowed. The main dam is set at a slope of about 2.7H:1V above elevation 474 and about 3.3H:1V below elevation 474, and appears to be stable. No unusual movement was observed. Surficial soils were somewhat saturated, but this was attributed to the heavy rainfall experienced in the days leading up to the field inspection. Surface runoff could be seen moving down the slope in several areas of the slope in the vicinity of the maximum section. Some shallow surficial erosion was noted near the base of the slope

(see Photo 11). The condition of the downstream slope at the saddle dike was found to be in similar condition. However, the surface did exhibit many shallow scarps owing to its 2:1 slope. Most scarps were healed and were fully vegetated. Based on discussions with AEP and IKEC personnel, this shallow movement in the saddle dike slope is a long-time condition. Previous filling at the toe had been done in an attempt to buttress the slope and mitigate the further sloughing of the slope. This was an issue noted in previous inspection reports and should continued to be monitored for further movement.

#11 – Soil Erosion Due to Surface Runoff at Toe Near Outlet Pipe Headwall

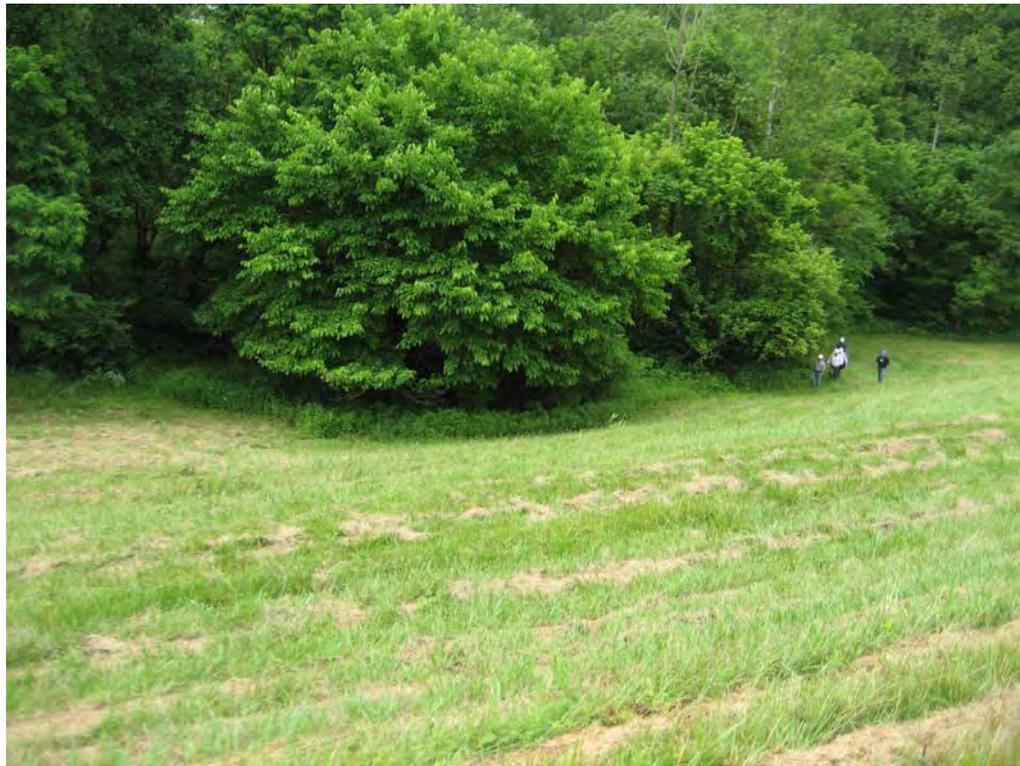
#13 – Downstream Face and Tree Growth Just Beyond Toe

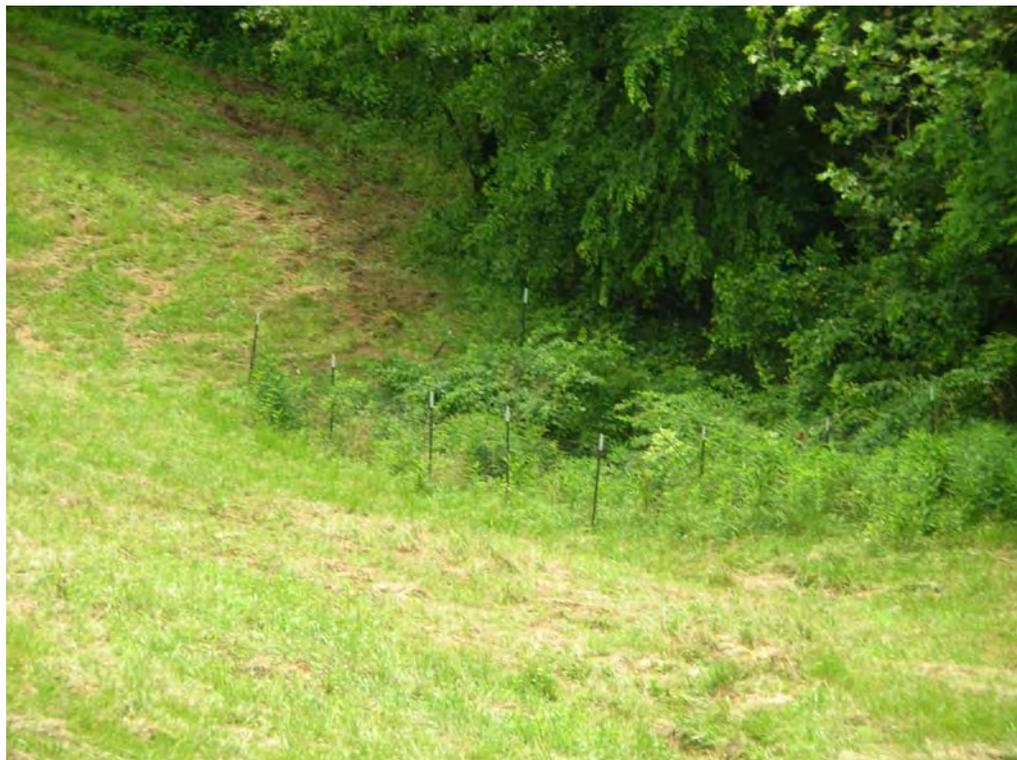
The end of the 72-inch RCP and associated head wall appeared to be in good conditions. Access to the structure was made difficult due to the dense overgrowth of the herbaceous vegetation on top of and the sides of the structure (see Photo 22). The tailwater extended about to the springline of the pipe. Flow was adequately dissipated prior to discharge to Panther Creek, with no erosion or other unusual movement observed.

#14 – Looking Downgradient at Toe at 72" Pipe Outfall Location; Note Heavy Growth

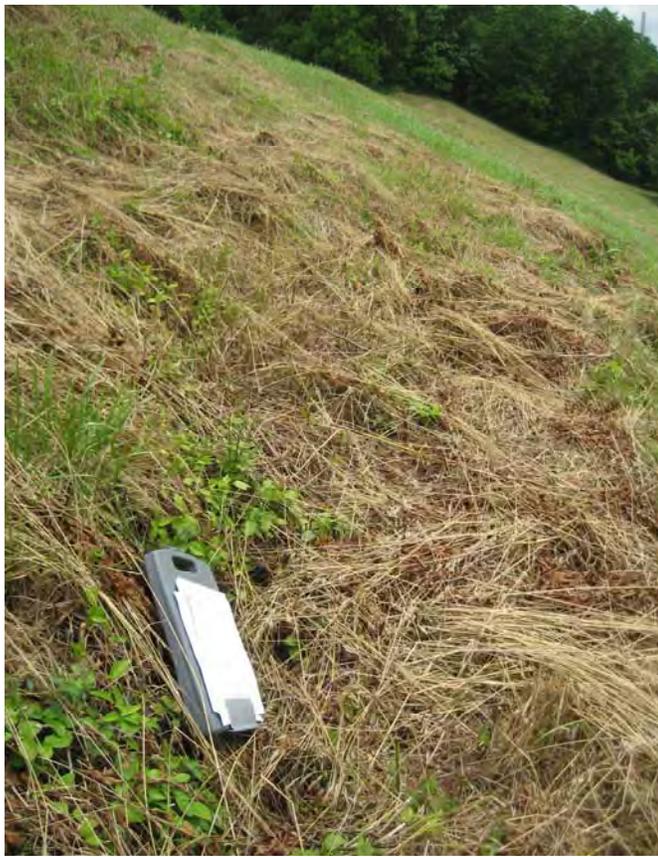
#17 – Typical Slope Scarp on Downstream Face on Saddle Dike

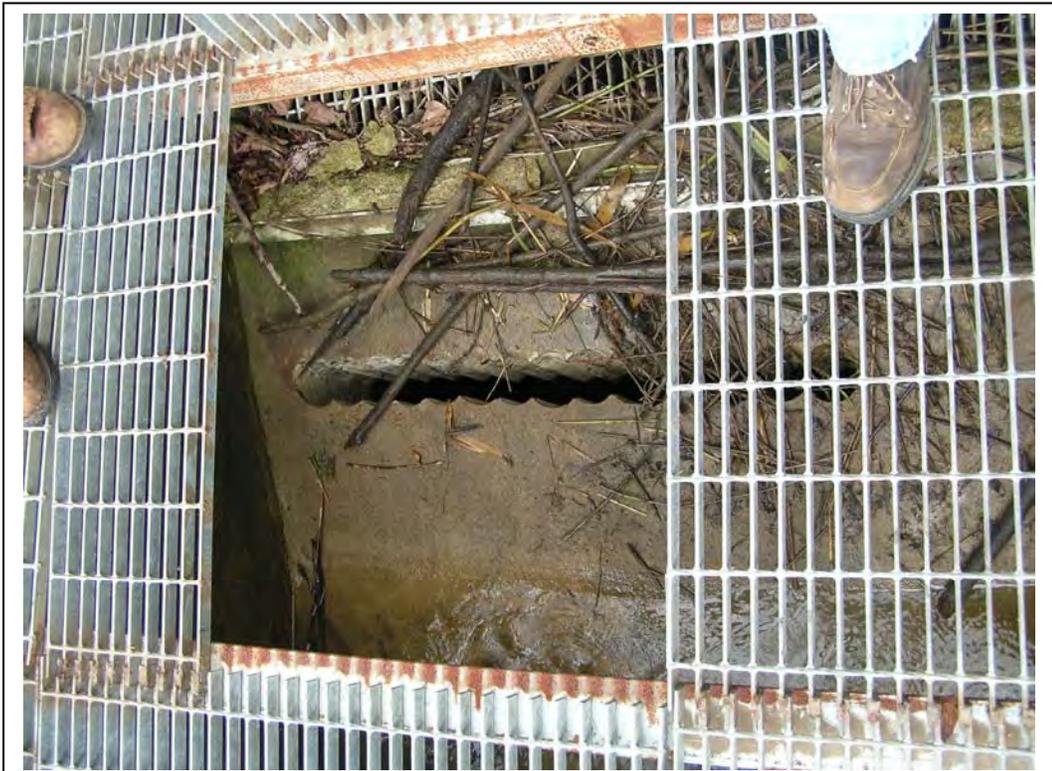
#19 – Mid-level Intake with Minor Woody Debris; Note Concrete Cores Creating Modified Intakes

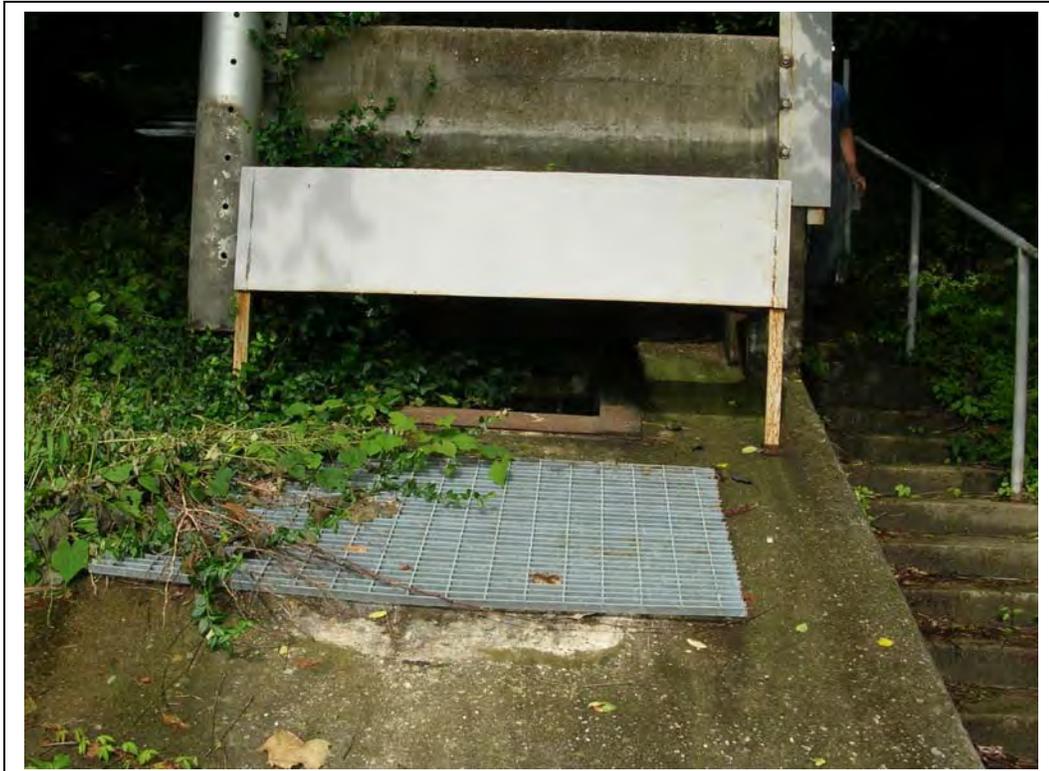
The water level in the pond is controlled by defined openings in the top of the reinforced concrete chute portion of the decant spillway. Access to the spillway was via the right abutment down a stairway which parallels the chute. The structure was in fair to good condition. Walkway grating, above the second intake, was in good condition. Some woody debris had accumulated on the grated inlets and newly cored opening (see Photo 19). More well established vegetation could be seen growing and partially blocking the third intake (see Photo 21). This debris and vegetation was subsequently removed by IKEC staff while we were on the site. IKEC staff demonstrated how the solid cover hatches over the intakes are removed. The ease to which one could open these hatches during a large storm event is questionable. The floating debris boom, located at the spillway intake, appeared to be in poor condition and partially submerged, allowing floatable objects to reach the intakes.

#21 – Minor Vegetative Growth Blocking Portion of Upper Intake (Vegetation Subsequently Removed)

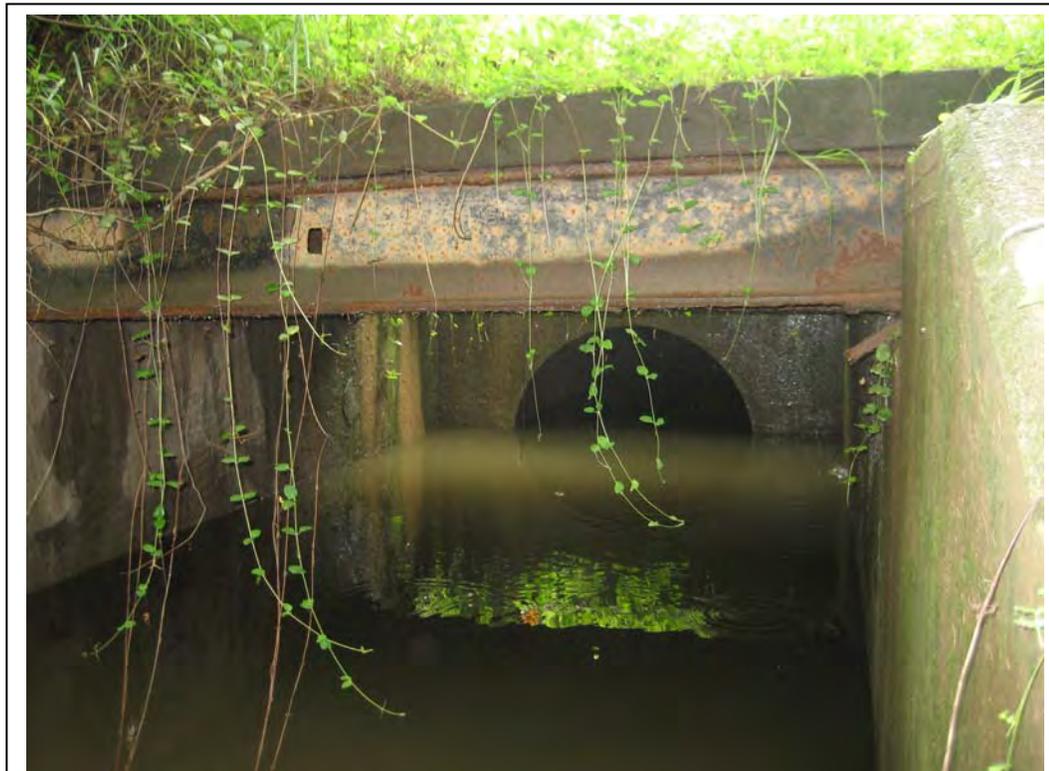
#22 – Outlet Headwall and Training Walls for 72-inch Discharge Pipe
